FIRE SERVICE RADIO NEWS

November/December 2014

Preventative Maintenance Improves Radio Performance and Reduces Replacement Costs

Minitor VI Voice Pager Delivers What You Asked For

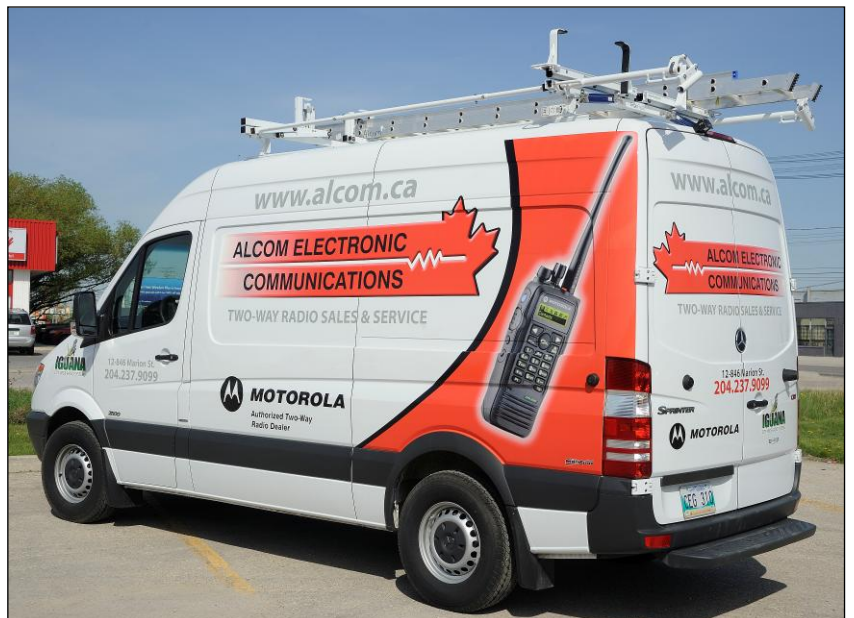
When the energy produced by the radio is unable to get through to the antenna, a high standing wave forms. The first consequence is poor radio performance. Poor radio performance is a warning sign that must be taken seriously.

Left unchecked, the standing wave will cause the power amplifier in the radio to overheat and fail. The risk of overheating is particularly high when the radio is being used intensely. The times when your radios get used intensely are the same times when you need your radios working well – when you are on an emergency scene.

Corrosion. If the truck body has corrosion where the antenna is mounted, the grounding may be inadequate. Corrosion at the top of the antenna mount will lead to a poor connection between the coax and the antenna. Corrosion within the antenna coil can cause the antenna to be mistuned. The older the apparatus, the more likely these problems are to arise.

Loose connections. The vibrations associated with driving on Manitoba's roads can lead to loose connections, where the coax connects to the radio,

where it connects to the antenna mount, and where the antenna screws on to its mount.

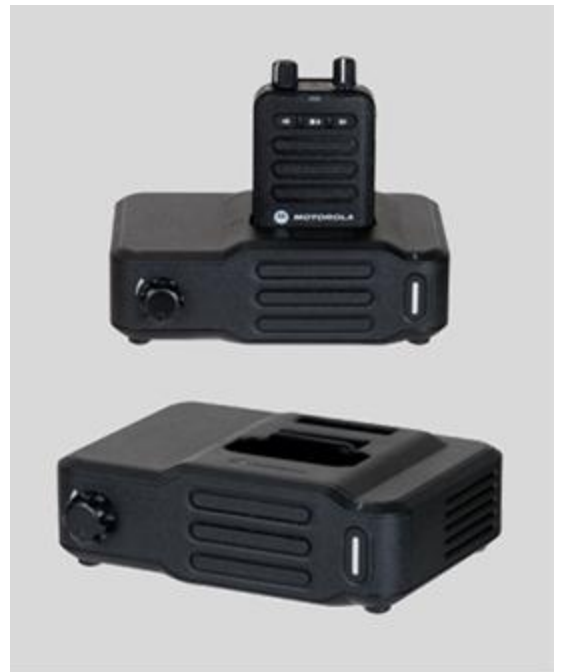
DESKTOP CHARGER
WITH AUDIO AMPLIFIER
AND EXTERNAL ANTENNA

An available option that is worth considering is the desktop charger/amplifier. It has a built-in audio amplifier that ensures a page can be heard throughout a home or place of business. It also features an external antenna. For buildings in which paging reception is weak, metal clad buildings for example, it is possible to mount an antenna outside the building and connect it to the desktop charger/amplifier. This configuration virtually guarantees that you will not miss a page.
